AIP SUP NR
28 / 2018

TAMPERE-PIRKKALA AERODROME, RESTRICTIONS AND TEMPORARY ARRANGEMENTS DURING WORKING PHASE 2 FROM 30 APR TO 14 MAY 2018

TAMPERE-PIRKKALA AD
RAJOITUKSIA JA TILAPÄISIÄ JÄRJESTELYJÄ / RESTRICTIONS AND TEMPORARY ARRANGEMENTS
30 APR - 14 MAY 2018

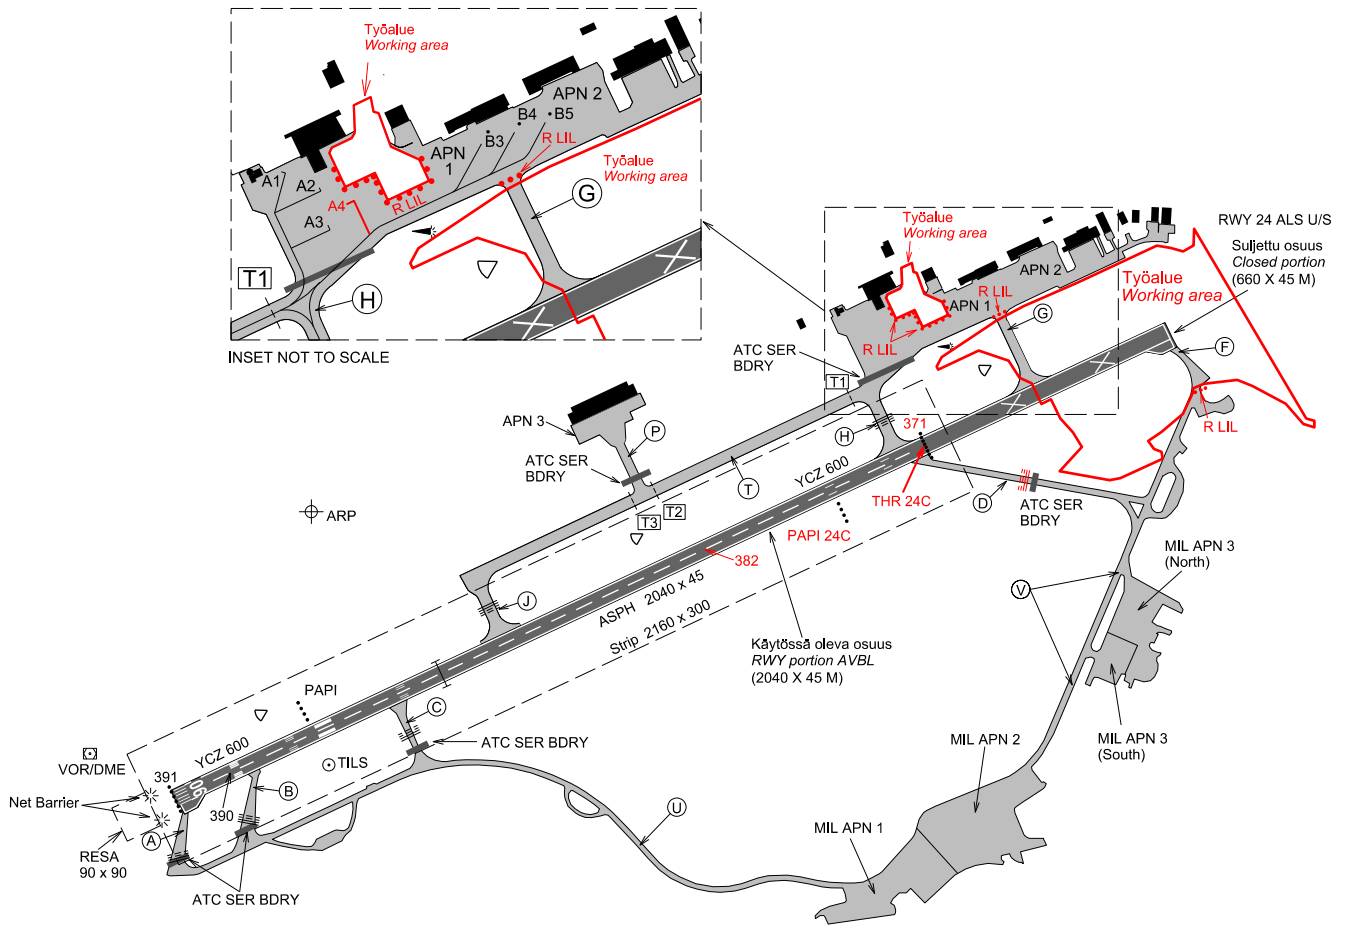
The working area and other areas closed to traffic are shown in the sketch on page 3.

Runway 06/24 is not in use.
Runway 06/24C is in use during the working phase.

Taxiways F and G are closed to traffic.

Stands A4, A5, A6, B1 and B2 are not in use.

Temporary stand **TEMPO A4** is in use (612509.90N 0233653.58E, PCN 50/F/A/W/T).

Holding position D is not in use.

Temporary holding position D is in use and marked with signs.

3.1 The closed portion of the runway is marked with lighted aids.

3.2 The working area is equipped with flags, cones and temporary lights (R LIL).
